Historical Flooding

Principal Flood Defence Structures

Our ref: NE9198 Your ref: North Herts SFRA 27 March 2006

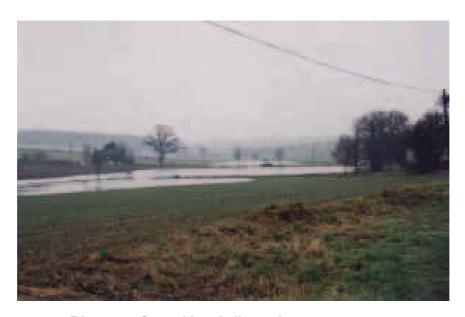
Photo 1: Out of bank flows in watercourse-Kimpton 2001

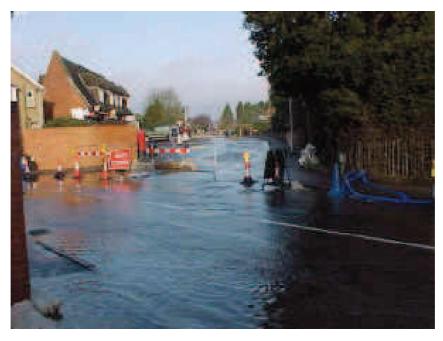
Photo 2- Flooding along Claggy Road/High Street-Kimpton 2001
