# **Preliminary Bat Roost Assessment**

St Mary the Virgin, Church Green,  
Great Wymondley, SG4 7HA

April 2021

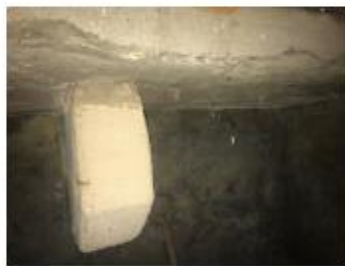
Figure 7

3.1.7 The sub-floor area and heating system vents and pipes were accessible and fully inspected. No evidence for the use of this area by bats was found. The area does not provide features that would be suitable for hibernation use by bats.

Heat exchanger and pipe work in sub-floor level below grid in nave floor.

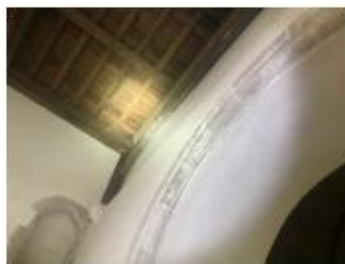
Figure 8

Detail of ceiling and ceiling support in sub-floor cavity, showing smooth, rendered surface with no crevices or cavities.
