Purwell Meadows

Local Nature Reserve (LNR)

GREENSPACE ACTION PLAN, 2022 – 2027

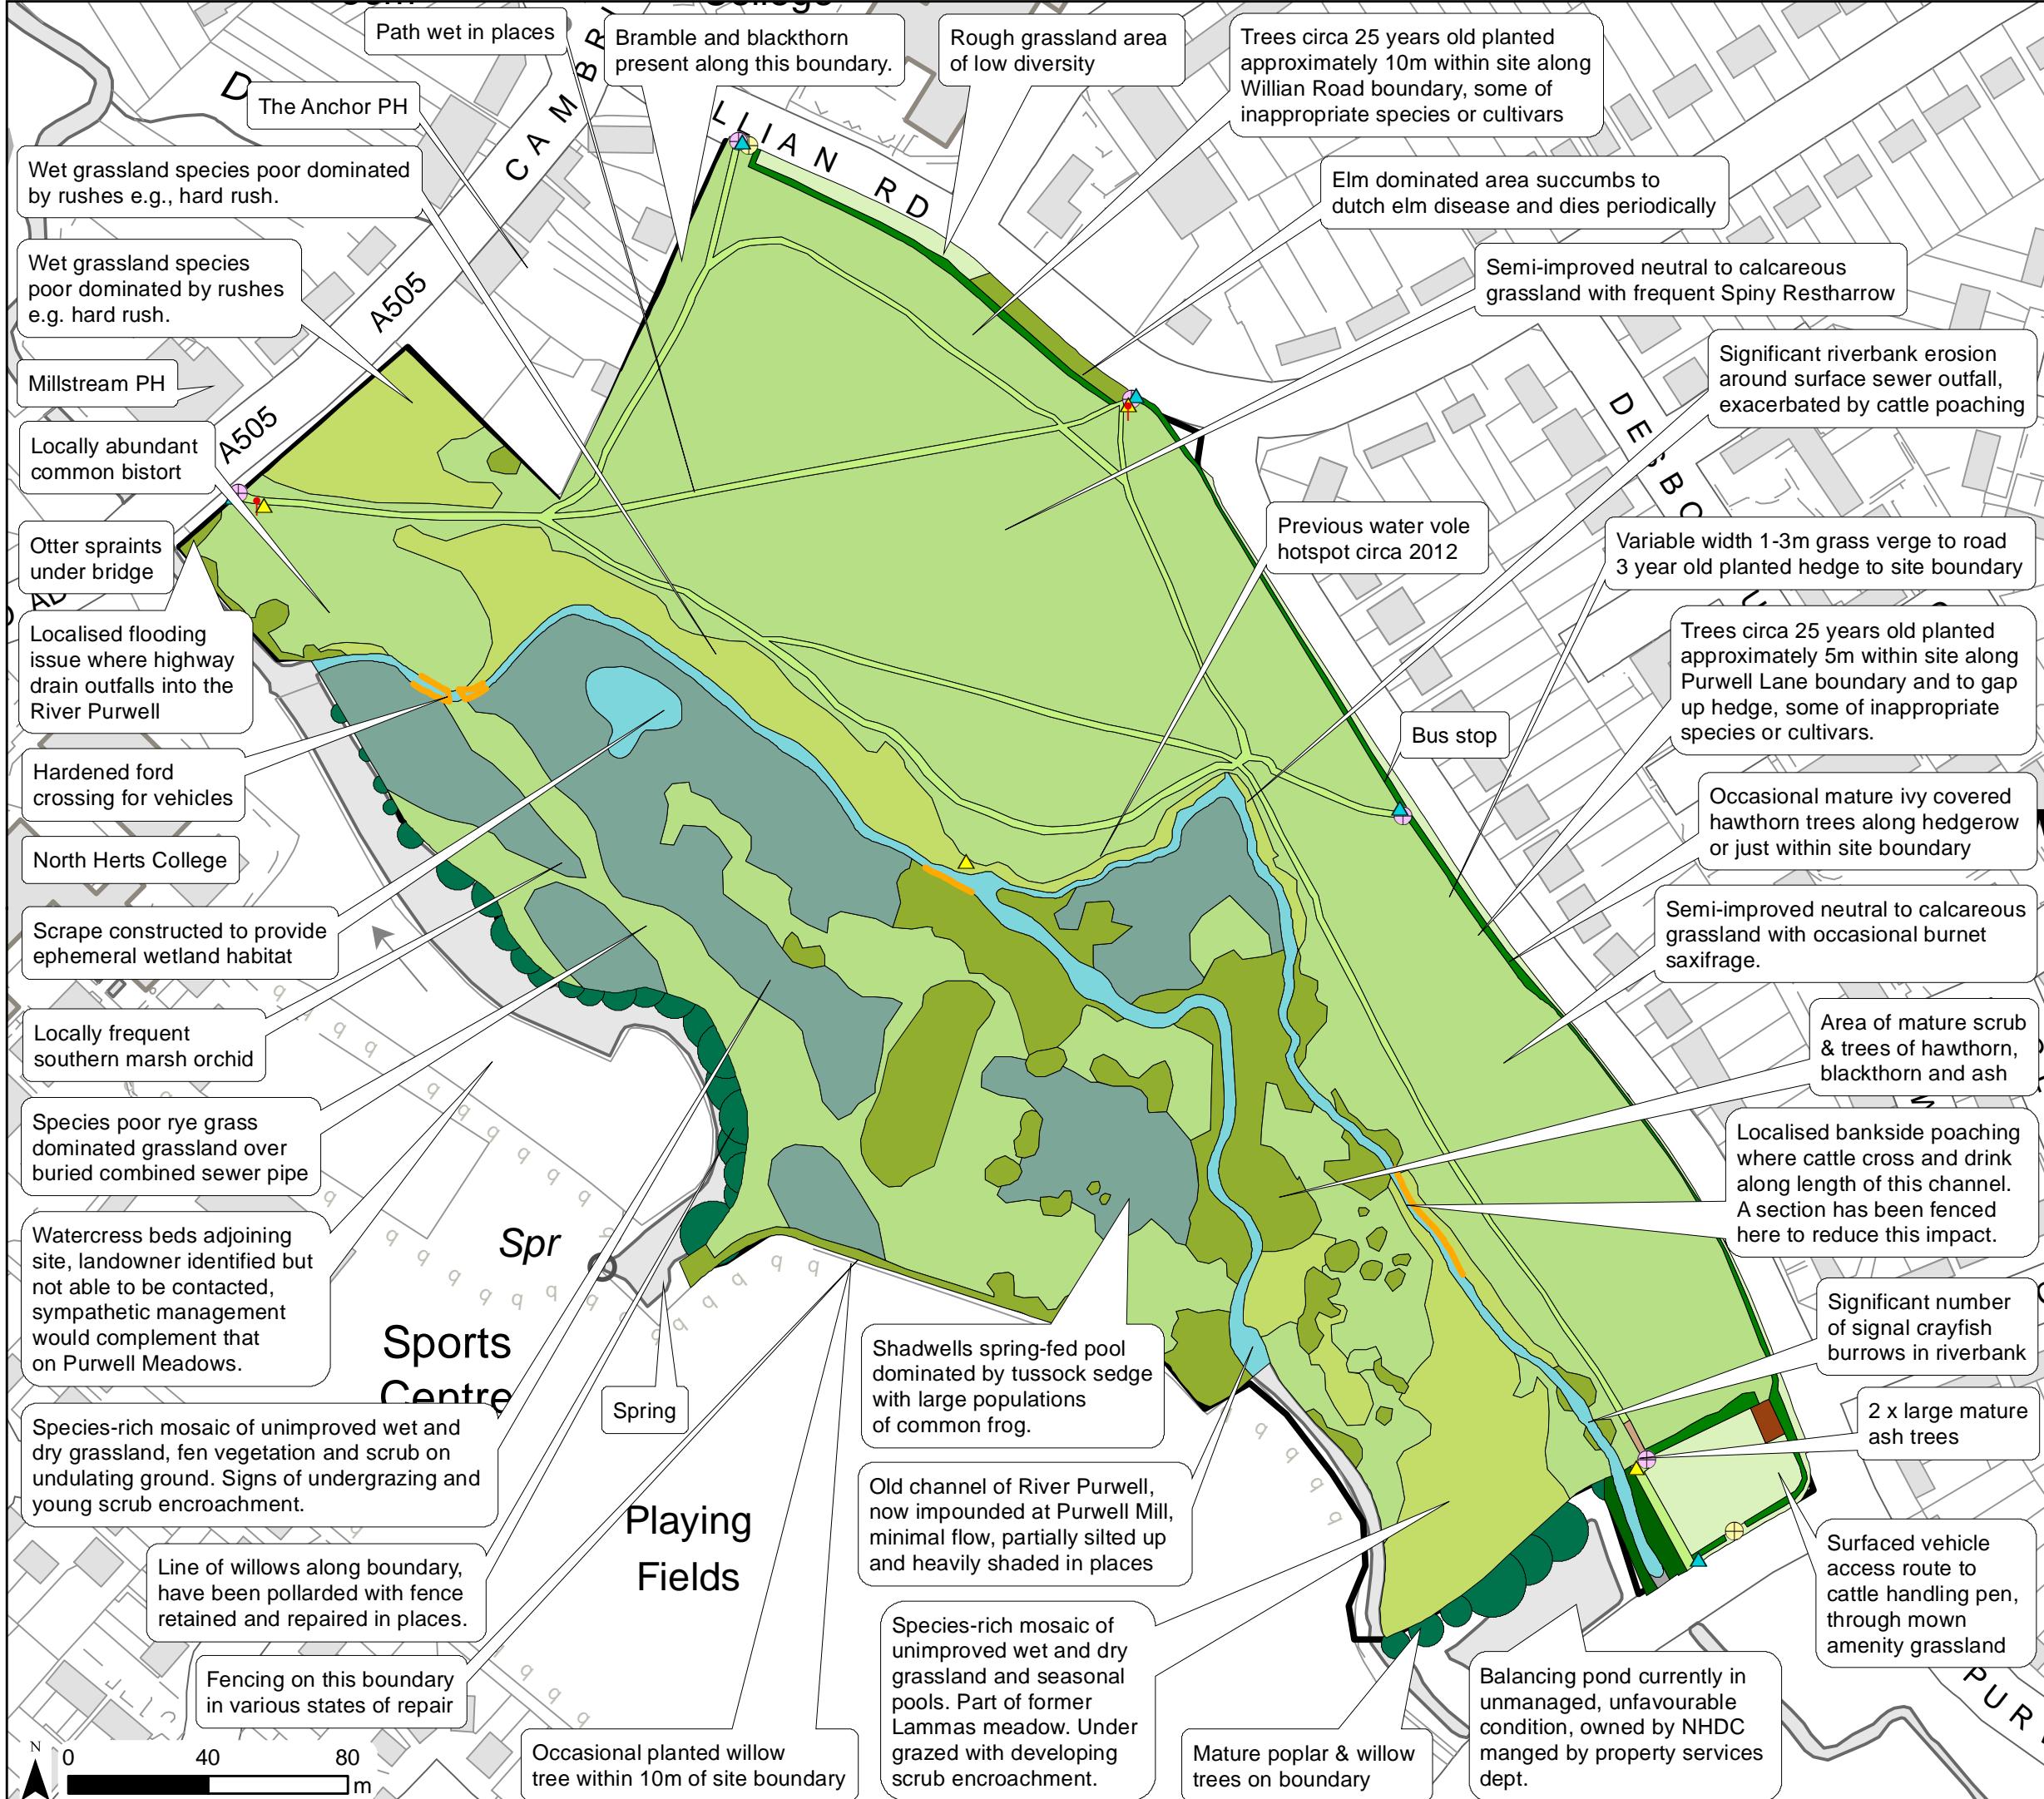
Site Description

- Amenity grass
 - Grass path
 - Hedgerow
 - Permeable path
 - Culvert
 - Scrub
 - Wet rush pasture
 - Dry calcareous/neutral grassland
 - Water
 - Fen vegetation
 - Woodland
 - Cattle Handling Pen
 - Trees
 - Site Boundary

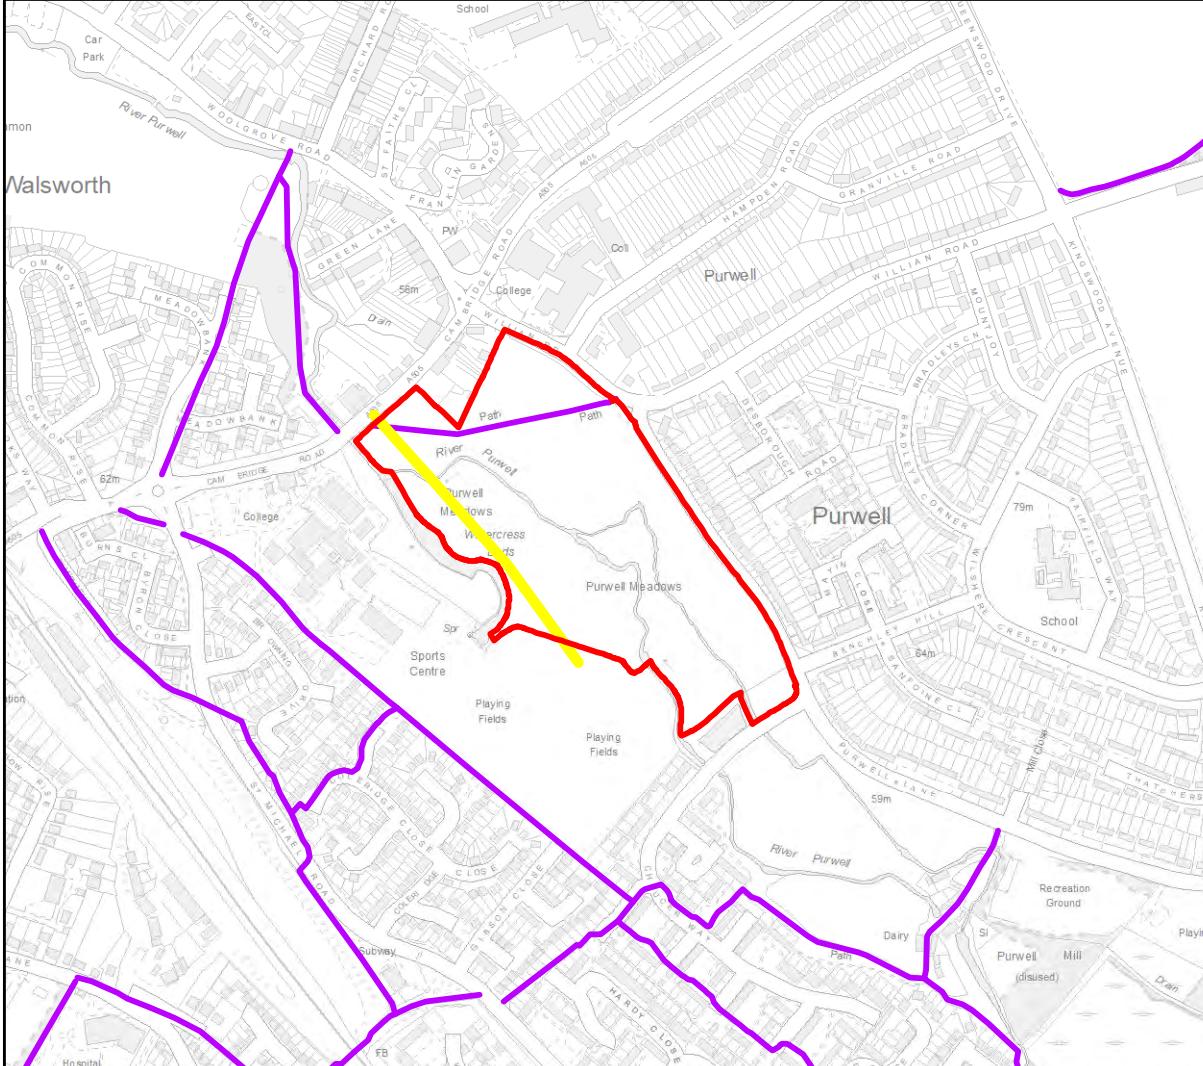
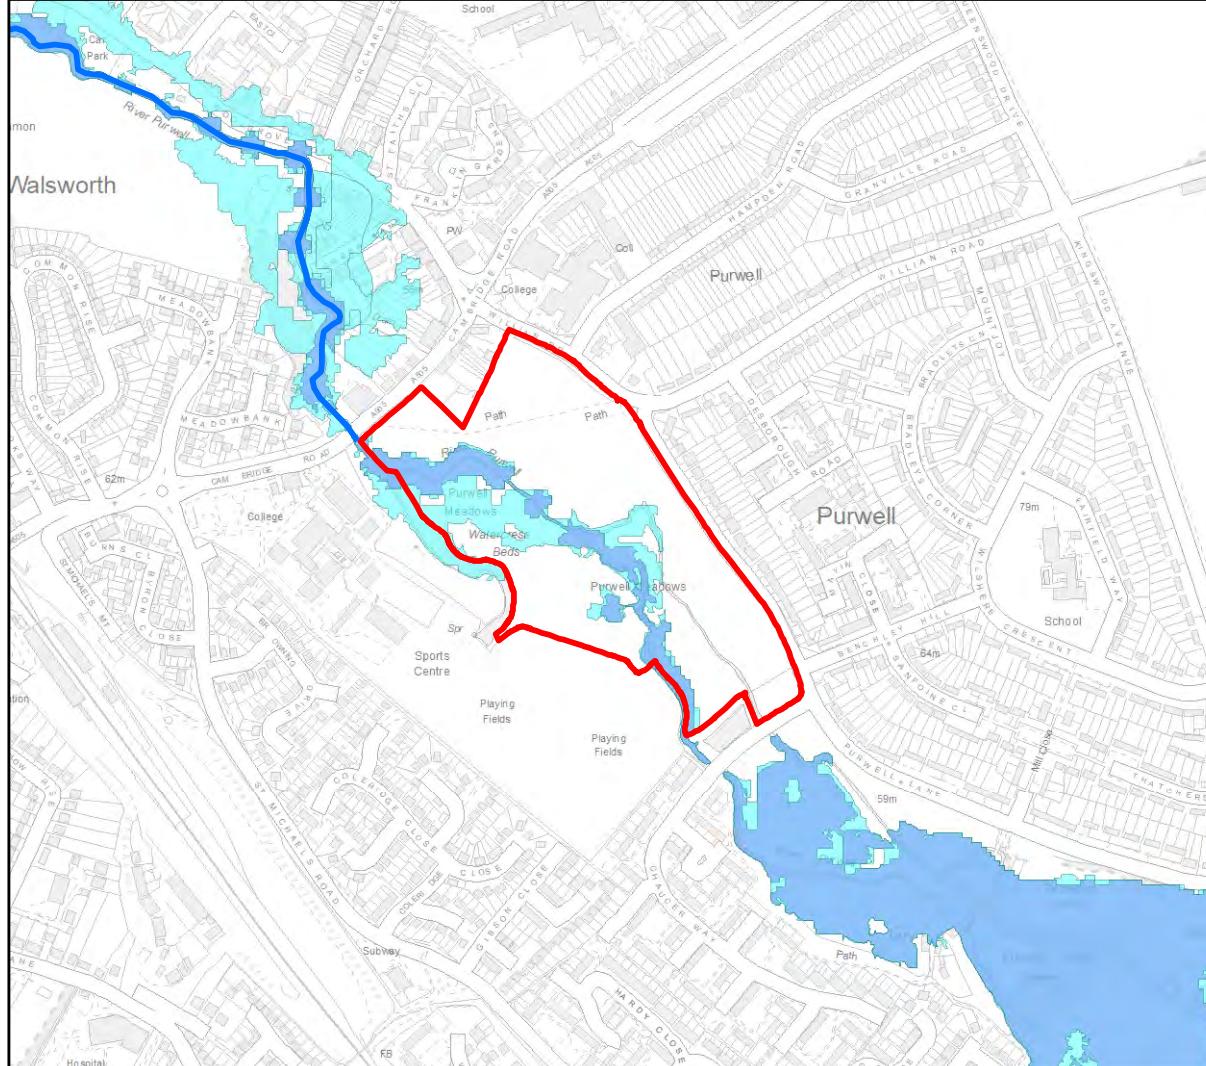
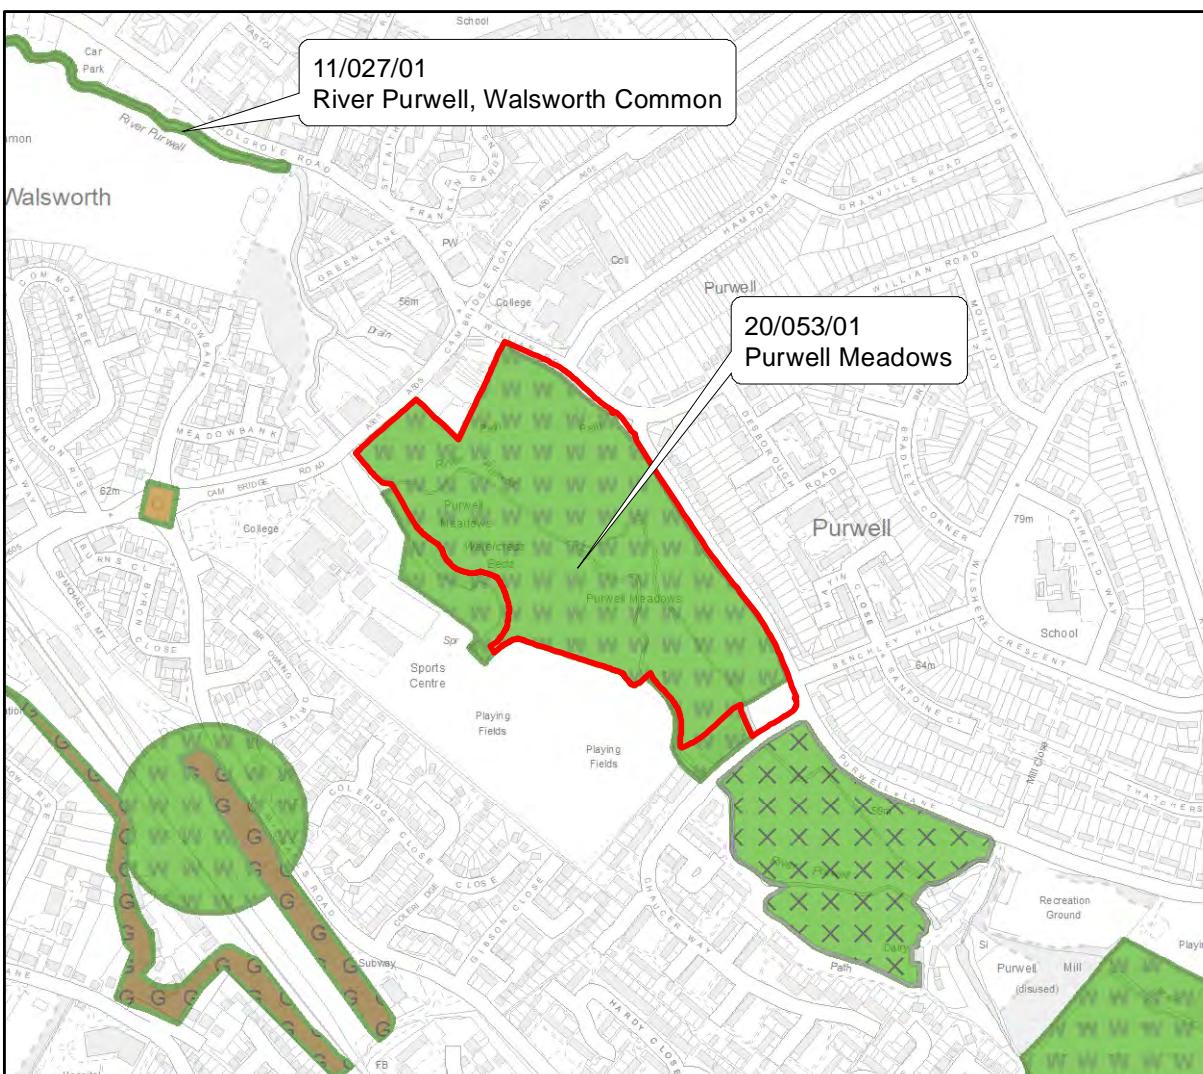
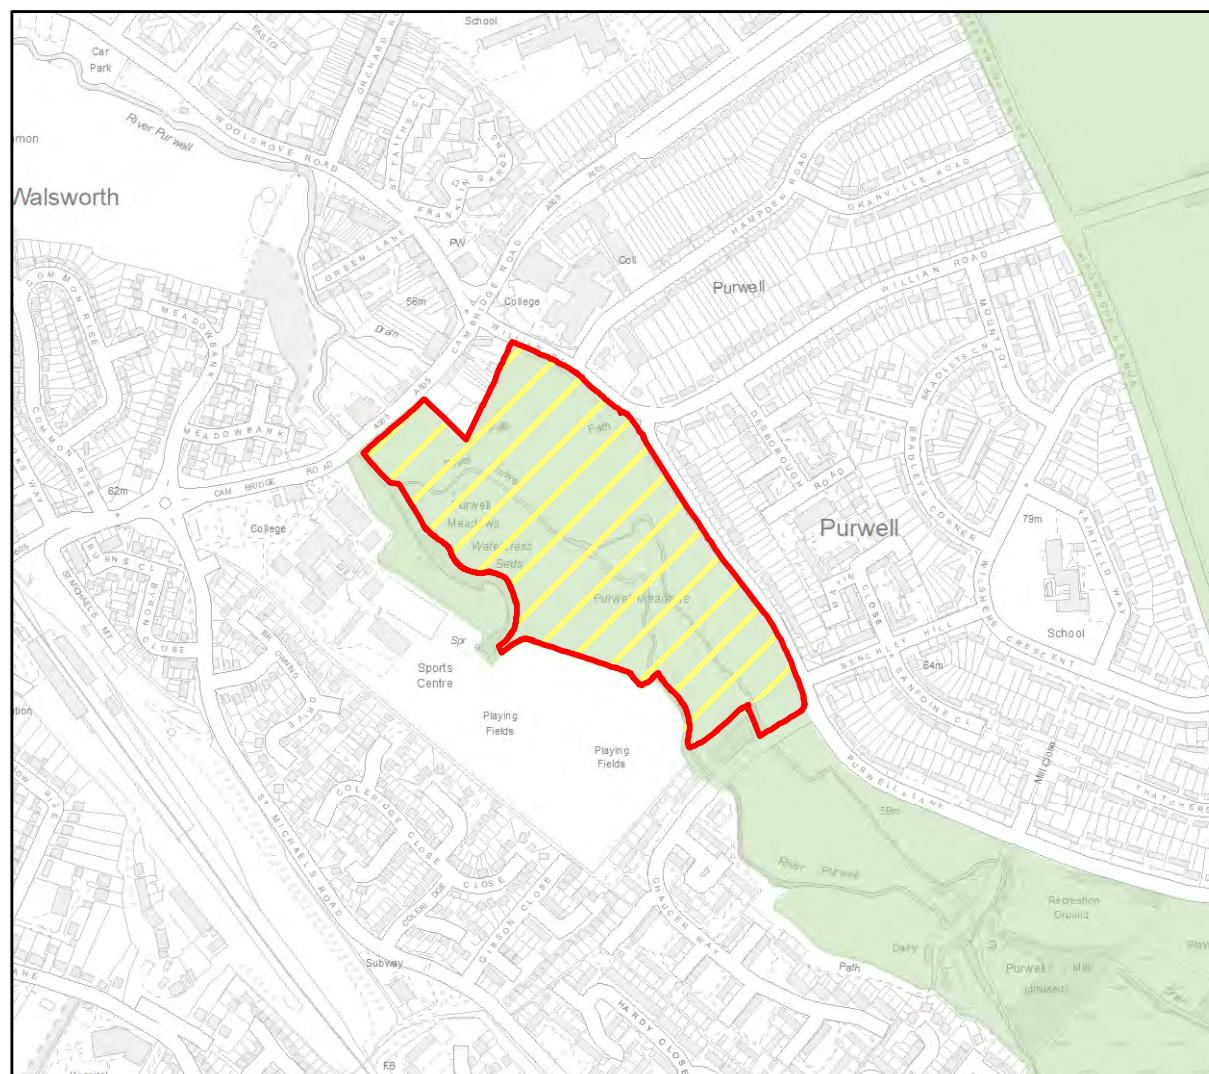
Constraints Plan

Utilities

Combined Sewer Pipe

Flood Zone Categories:

Main River

Flood Zone 3

Flood Zone 2

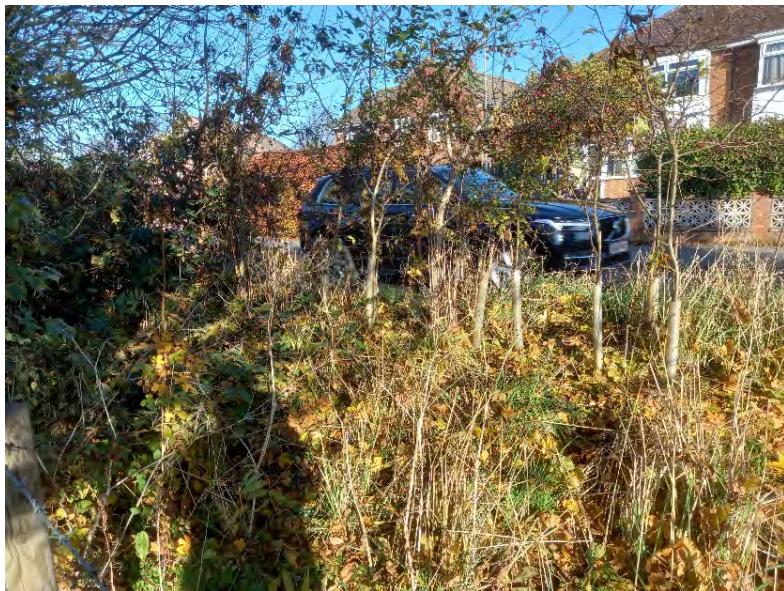
Recently planted hedgerow along Purwell Lane

The hedgerows along the eastern boundaries were restored in 2012 with a process of crown lifting existing trees, thinning, coppicing and replanting. This has been largely successful but ongoing maintenance needs to continue to achieve good establishment of the planted trees/shrubs. Re-mulching and/or spraying growth around the base of the planted trees/shrubs is required to help plants establish strongly.

The temporary chestnut pale fencing along the section of hedge on Chaucer Way can be removed in year 1 of this plan if it is judged to be established sufficiently that the threat of vandalism is no longer a concern. Guards and canes should be removed from the hedge plants in year 1 to give them the best chance of establishment if this has not already been carried out. The hedgerow along Chaucer Way will be large enough to be able to lay during year 4 of this management plan. Before this time, some work will be needed to make it more manageable to lay through trimming. Over the long term this management will provide a thick and attractive hedge which is of benefit to wildlife and act as a barrier for livestock. A section of hedgerow along Purwell Lane could be laid in year 5 if it is deemed large enough.

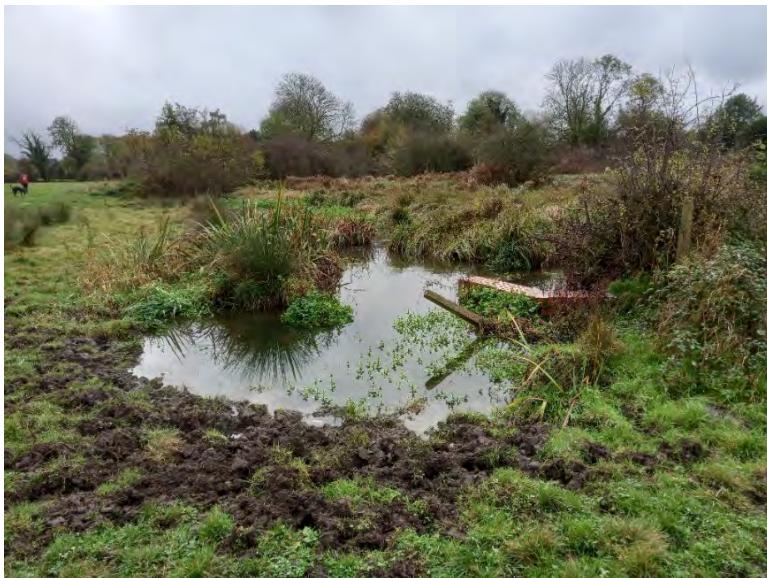
Poached area around culvert outfall into the river channel

The old mill channel has good flows with some areas where silt deposition is high. The riverbanks will continue to be susceptible to erosion which has been exacerbated through poaching from livestock. The work over the course of the previous management plan, fencing short sections of the channel has stabilised most of the worst sections of it. The main section where the banks are still being poached is around the outfall of the culverts into the river channel. This area should be temporarily fenced to exclude cattle and allow for some natural vegetation regeneration.

Poaching by livestock can create opportunities for diversification of the river channel particularly the old mill channel which is in the main quite similar in profile and depth for much of its length. If poached areas are given the opportunity for vegetation to re-establish/recover naturally, e.g., through temporary fencing, they can stabilise the bank and with natural water action create a more varied river channel that benefits wildlife e.g., young fish refuge areas. In addition, giving the cattle alternative drinking sources e.g., pasture pump, in a drier area of the site away from the riverbank, would help to decrease poaching on the riverbank. The installation of a pasture pump will be considered following consultation with the grazier and once further progress is made on reducing access points for cattle to the water (this may be towards the end of the period covered by this GAP). Work will continue to improve the river habitat for Water Voles through temporary fencing to encourage populations back to the site. NHC and CMS will work with HMWT on any potential projects to encourage Water Voles to use the site when the habitat is suitable

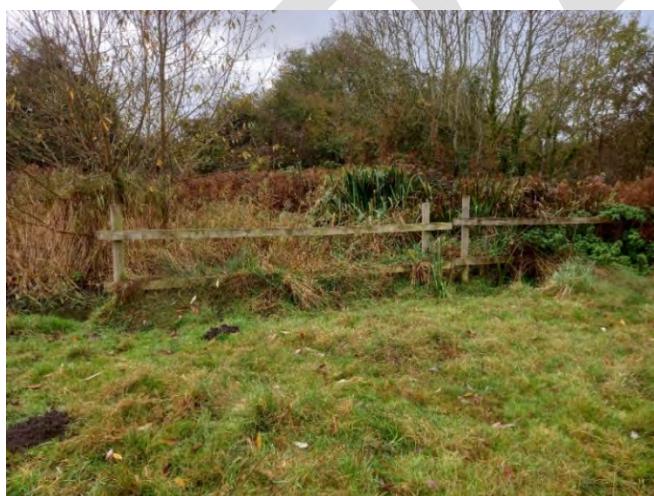
Temporary wooden fencing to protect the riverbank from erosion

One particular problem spot on the River Purwell is a 90-degree bend near in the centre of the site, the location of two culverted pipe outfalls. It has become badly eroded in recent years due to a combination of location, river action and poaching by cattle when coming to drink. The pipes and headwall of the surface water sewers are no longer on the bank and instead increasingly in the centre of the channel as the natural river action erodes round the back of the headwalls. In consultation with Anglia Water the asset owners, Environment Agency and Hertfordshire County Council there should be works to address this issue. The surface water sewer pipe from Purwell Lane should be deculverted into a ditch to slow surface water flows from the road and allow pollutants to settle in the ditch rather than entering the river. A crossing to carry the riverside path will be required. To accompany this the headwall of the 2nd pipe should be moved back to the current riverbank and outfall put in at an appropriate height to prevent any hydrobraking backing up the water up the culvert as currently appears to occur. This work cannot take place until a suitable agreement with the grazier is in place and funding is obtained.

Upstream from the pipes, brash buildouts should be constructed to narrow the river channel and give vegetation a substrate to naturally colonize. This will need to be protected with temporary fencing to keep the cattle off while vegetation establishes.

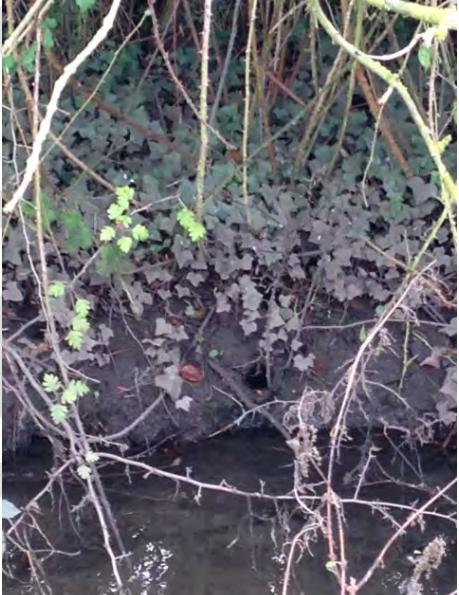
Picture 4: Holes in River bank

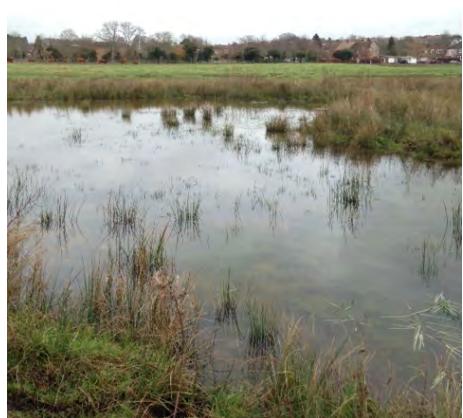
Picture 6: Scrape in Compartment 2

Areas of wetland were identified as drying out due to pressures on the water resources feeding them resulting in a poor diversity of species and unfavourable condition of the habitat. A shallow scrape was constructed in 2013 to lower soil levels closer to the current water table. This is being allowed to revegetate naturally, it already shows a diversity of plants including Stonewort sp., Water Crowfoot sp., Water Plantain & Plicate Sweet-grass and is being used by wading birds such as snipe and little egret.
