North Hertfordshire District Council

Charlton

Conservation Area Character Statement

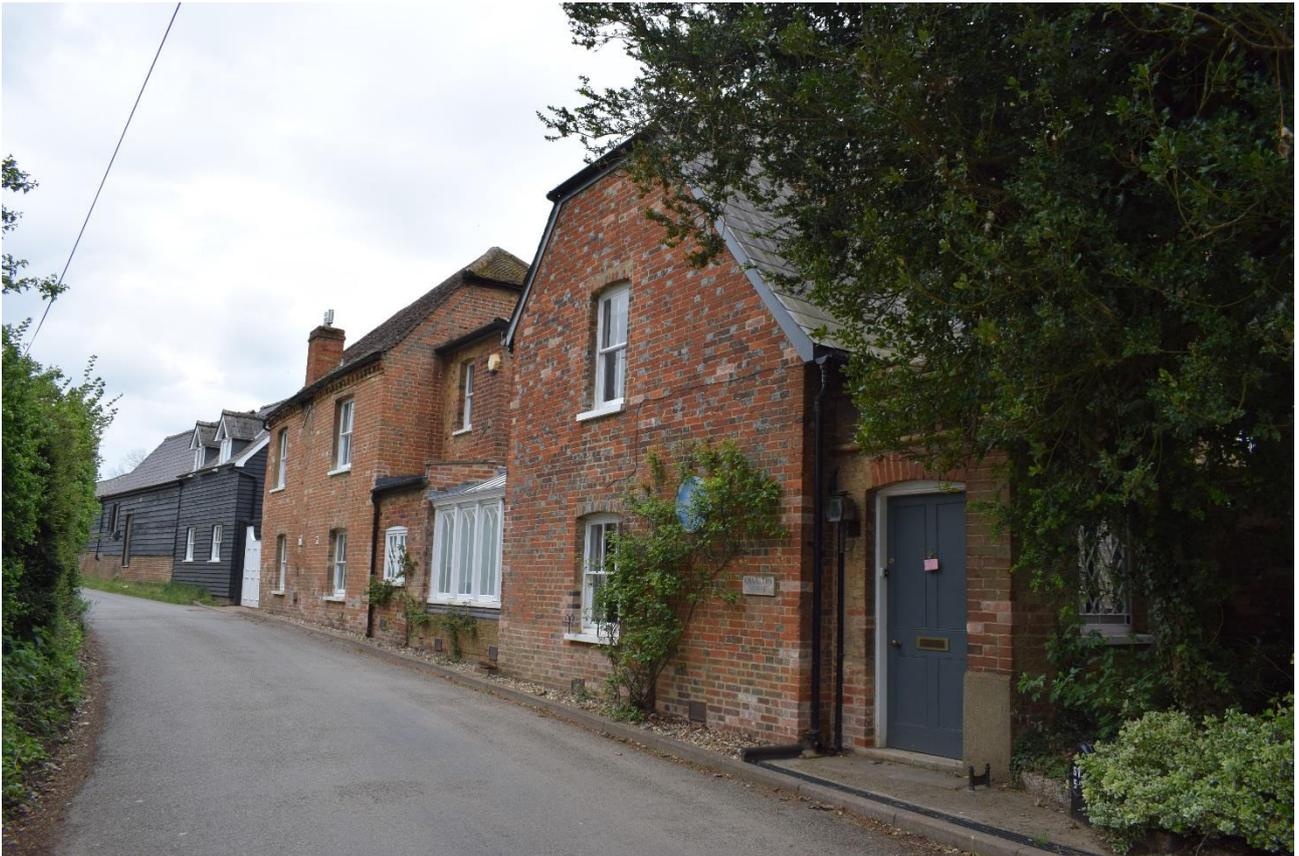
Fig 2.1 Charlton House on Charlton Road, looking south toward Mill Farm Barns. Charlton House is a Grade II listed building and the Mill Farm Barns also make a positive contribution to the character of the Conservation Area.

- 2.1.4 The Grade II listed Charlton House (Fig 2.1), near to the junction between Charlton Road and Brick Kiln Lane, is in red brick with blue brick headers employed in a front wall of Flemish bond, something that is echoed in other red brick buildings to varying degrees of proficiency. Charlton House also has a brick dentil cornice and a variety of roof forms, together with a gothic-detailed orangery and window fronting onto Charlton Road. A number of the historic brick buildings in Charlton have been colour washed in white or cream.

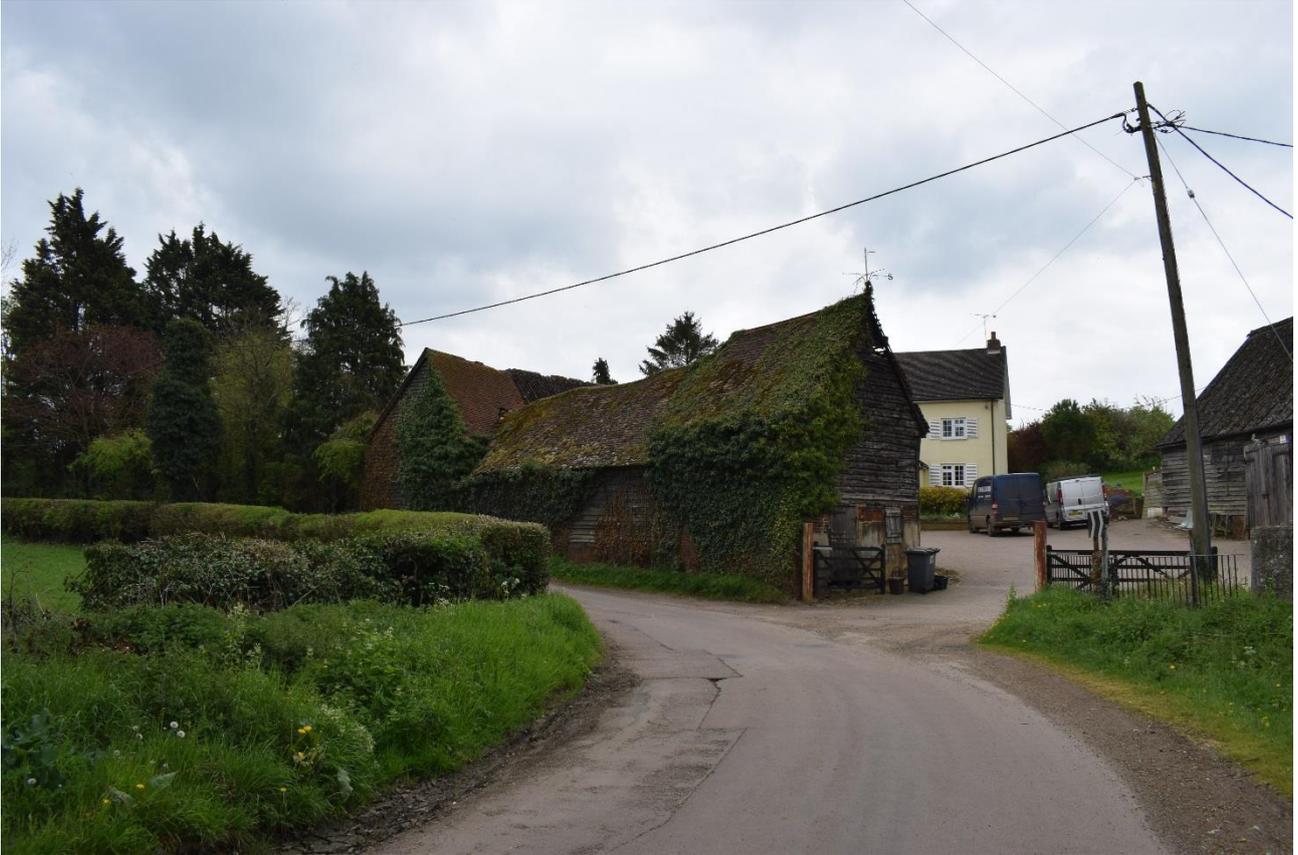
Fig 2.2 Wellhead Farm and barns, looking north-west along Maydencroft Lane. The barns are Grade II listed buildings.

- 2.1.6 There are both historic and modern timber buildings in Charlton, the oldest being the Grade II listed 17th and 18th century granary and barns at Wellhead Farm (Fig 2.2), these with red brick sills below dark weatherboarding. This same general style has been used at Mill Farm Barns (Fig 2.3), where more modern barns, including one fronting directly onto Charlton Road, have black-painted weatherboarding and shorter brick sills with slate roofs.

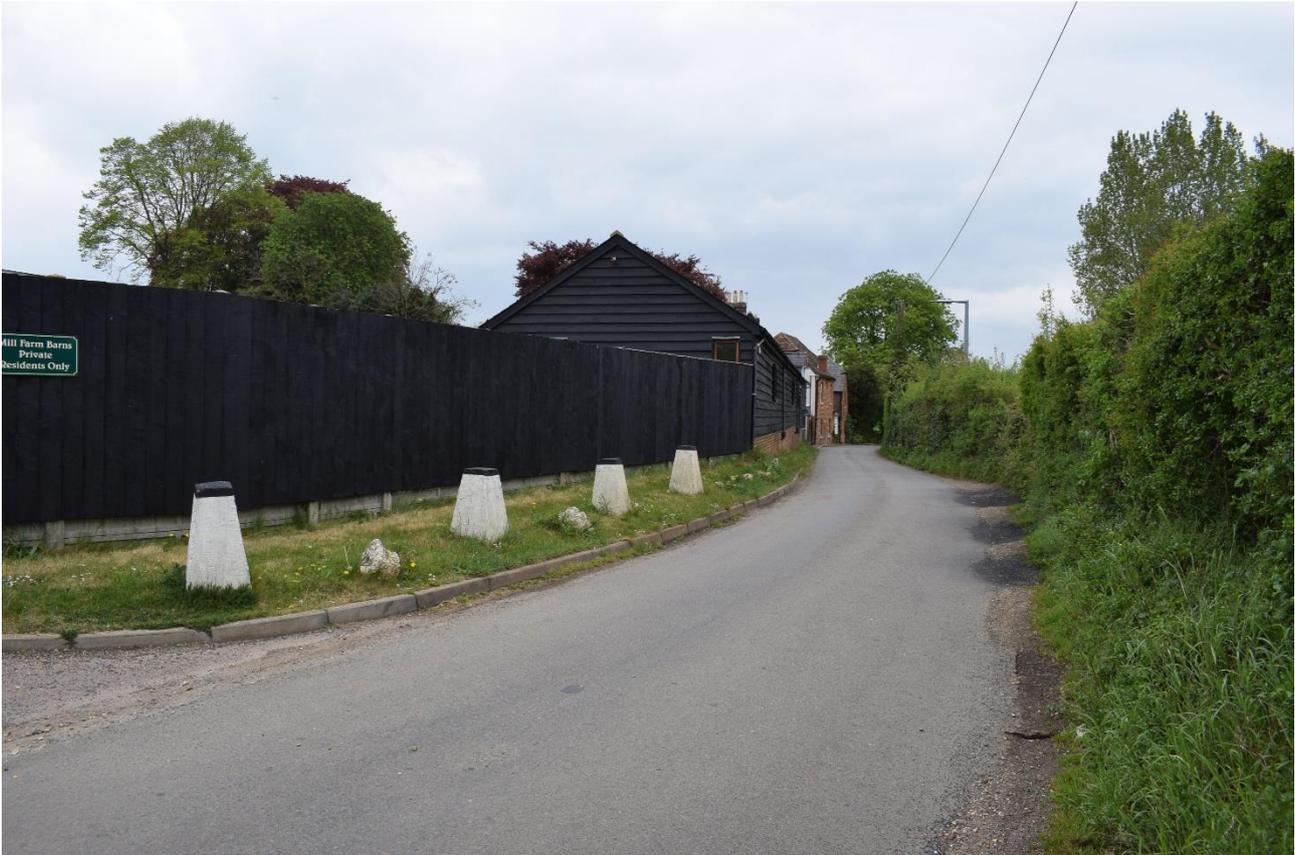
Fig 2.3 Mill Farm Barns, looking north along Charlton Road. Mill Farm Barns make a positive contribution to the character of the Conservation Area.

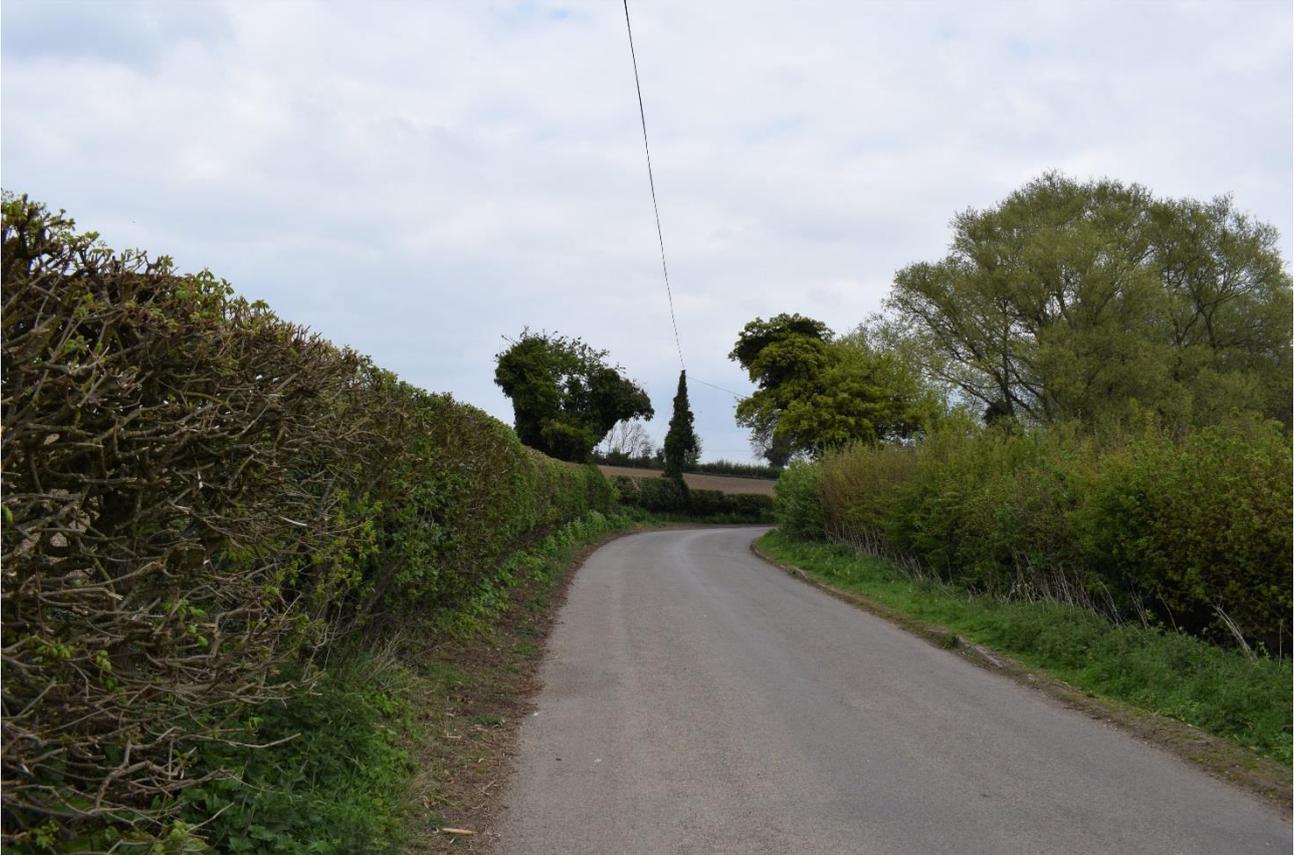
Fig 2.4 Hedged boundaries on Charlton Road, looking north. Hedged boundaries are a common feature of the Conservation Area, contributing to its agricultural and rural character.

- 2.1.9 The agricultural and rural character of the area comes from the use of hedged boundaries, in many cases containing hedgerow trees, and the density of tree cover to the line of the water management for the mill. At the south of the Conservation Area, Charlton Road has hedges on both sides with thin grass verges (Fig 2.4). The fields surrounding the spring adjacent to Wellhead Farm are also bounded by hedgerows near to Charlton Road and fenced as they approach the slope to the east of the Conservation Area. Maydencroft Lane is also lined with hedgerows containing occasional trees. Charlton Road remains hedge-lined on both sides until it reaches the second spring and the southern extent of the mill pond where, the west side of the road remains hedged while the eastern side is more open, still with planting and trees, but lower cut and less established, allowing a view over the ponds. While the hedgerow on the west side of Charlton Road continues, the east side is bounded by a modern wooden fence south of the residential buildings opposite Windmill Lane. To their north is a brick wall fronting directly onto the street which turns the corner towards the mill and forms part of the boundary of Mill Farm. That part of Charlton Road that runs east past Mill Farm is partly hedge-lined, but open in front of buildings and with a gate and corrugated iron hoardings over the mill stream. Mill Farm Barns and Charlton House provide a gap in the hedgerow on the west side of Charlton Road, the house fronting directly onto the road and the black painted fence of the farm sitting behind a grass verge with concrete kerbstones and painted concrete blocks. Opposite this, the east side of Charlton Road has a hedge that runs as far as The Windmill public house building. North of Charlton House, Charlton Road is edged by a low brick wall with fields beyond, while on the east side, north of Brick Kiln Lane, is a concrete-kerbed pavement in front of houses and a car park.

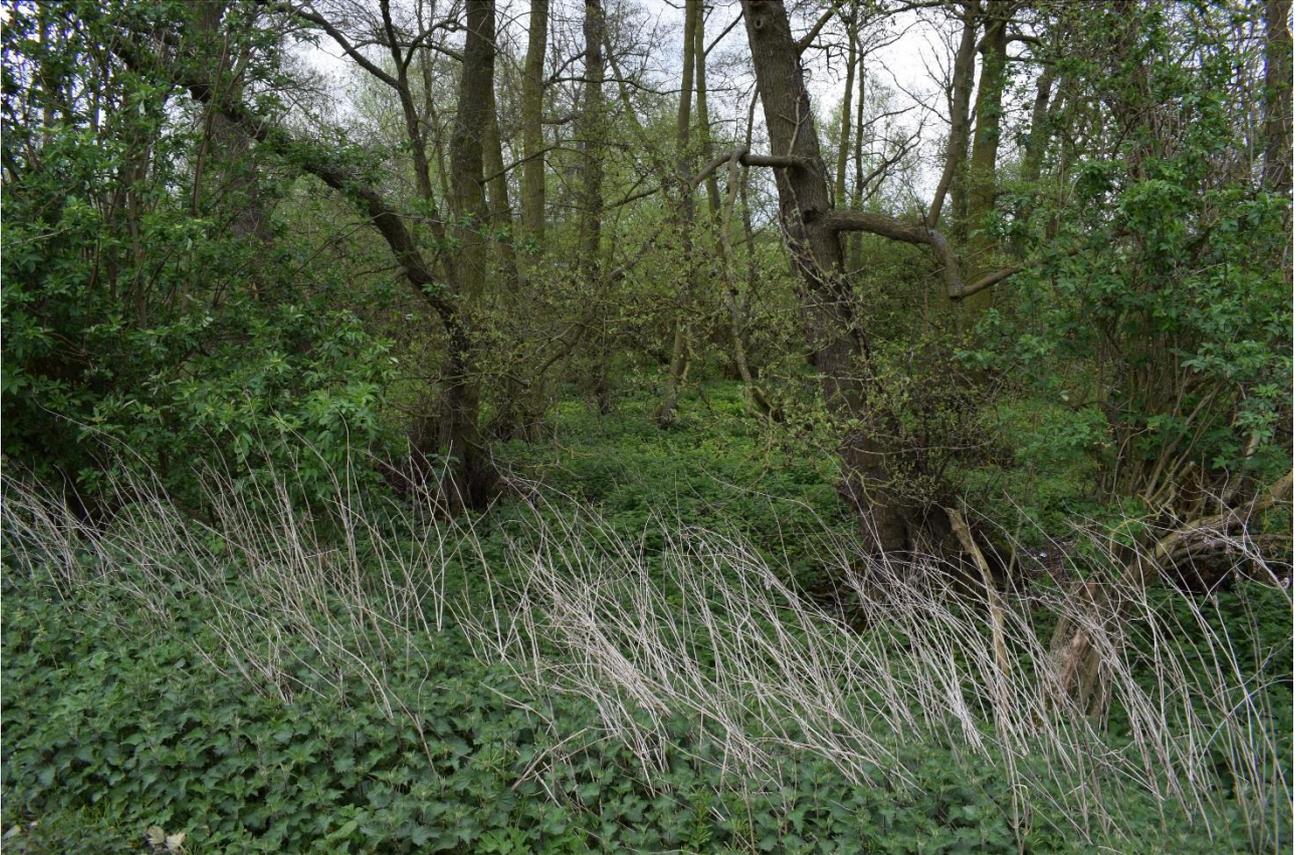
Fig 2.5 Trees south of the mill pond off Charlton Road. The tree planting around the streams, leats, ponds and springs at the core of the Conservation Area present a soft, rural character.

- 2.1.10 The majority of trees within the Conservation Area are along the mill stream, north of Brick Kiln Lane and south of the mill pond (Fig 2.5). Significant tree planting occurs elsewhere, such as at the spring west of Wellhead Farm, at the junction of Charlton Road and Maydencroft Lane, within the grounds of Wellenhevet, and within the Charlton House property.

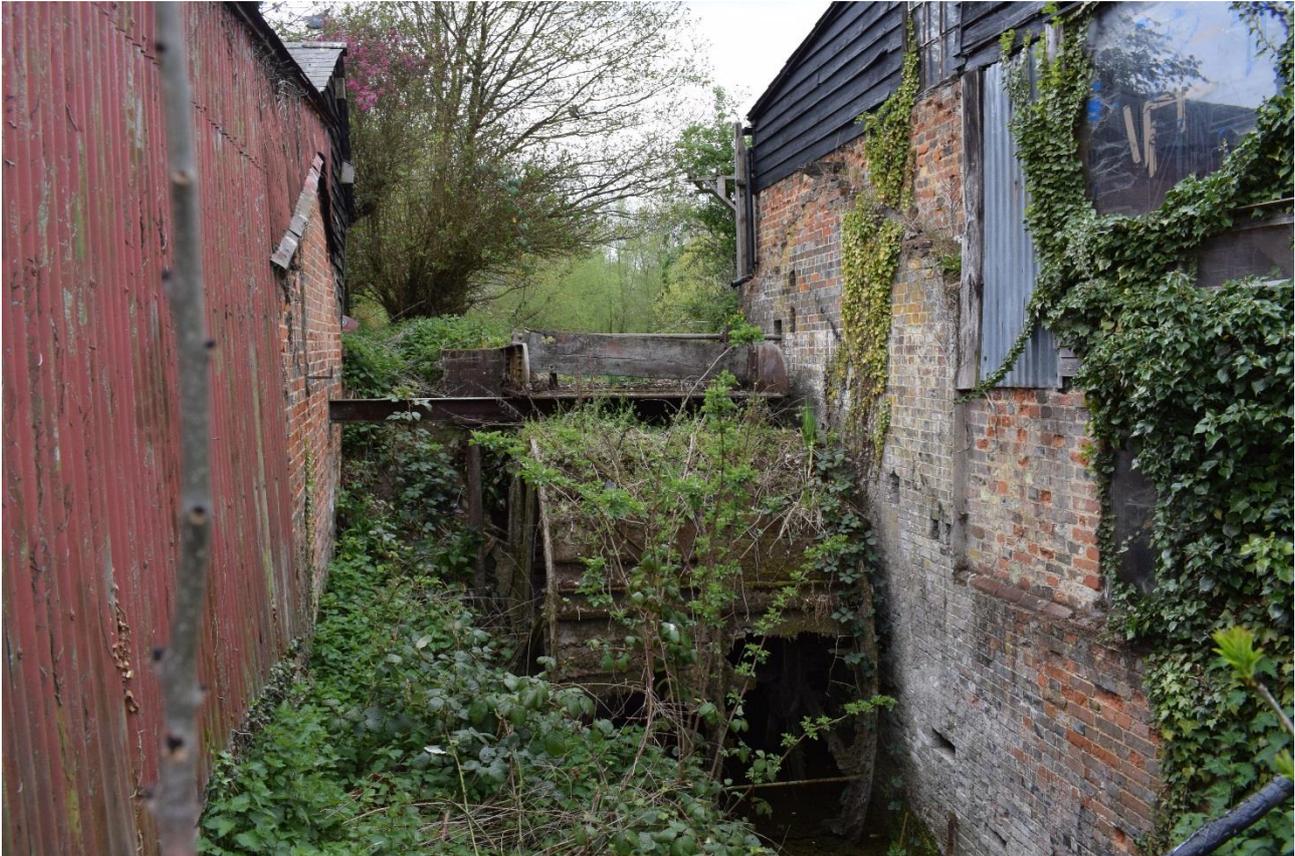
Fig 4.1 Overshot mill wheel at Mill Farm. The presence of a mill wheel contributes to the readability of the historic milling landscape, though there is an opportunity to renovate and open this up.

- the over-shot mill wheel at Mill Farm could be renovated and opened up to further enhance the readability of the historic milling landscape through the settlement (Fig 4.1)
- the mill at Mill Farm appears to be at risk (Fig 4.1) and so there is an opportunity for works to stabilise or enhance this structure
- the stream would benefit from suitable enhancement to the area
- there is an opportunity for further historic interpretation through the village to better explain the intact historic milling landscape and its features to visitors.
- the Conservation Area could be provided with sensitively designed and located bin storage to better facilitate refuse collection
- the retention of The Windmill public house as a community facility
