PROPOSED RESIDENTIAL DEVELOPMENT ACCESS, ASHWELL

STAGE 1 - ROAD SAFETY AUDIT/ASSESSMENT AUGUST 2017

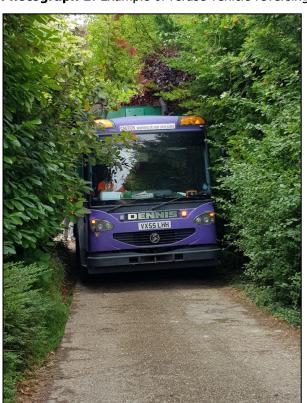
Photograph 1: Example of refuse vehicle reversing along Ashwell Street.

- 1.8 Ashwell Street is an un-adopted private carriageway and is approximately 2.5-3 metres wide and is partially paved, (although in a relatively poor condition) and that serves 6 residential dwellings. There are no formal footways or street lighting along its length.
- 1.9 Information received as part of the audit brief has identified that due to the lack of adequate turning head facilities on the access road to 45-57 Ashwell Street, larger vehicles such as refuse trucks are required to reverse along its length to gain access (**Ref: Photograph 1**).

- It is proposed that the main point of pedestrian access to the site will be provided to the north of the proposed development site via the PRoW and eastern extent of Ashwell Street that currently provides access to 6 residential properties. Although no details have been provided as part of the audit brief, with regard to the anticipated increase in pedestrian/cycle movements that would be associated with the proposed development that would use this pedestrian route, it is considered that an increase in pedestrian movements could potentially result in an increased risk of pedestrian/vehicular collisions on Ashwell Street. This issue would be exacerbated at such times when large vehicles are required to reverse along Ashwell Street, and during the hours of darkness, although, it is also noted that reversing vehicles would have limited if no visibility to the rear of their vehicle during the hours of daylight, due to the width of the carriageway and presence of overhanging vegetation within the verge.

- 2.7 It is also noted that inter-visibility between pedestrians leaving the proposed site and entering Ashwell Street and vehicles traveling along Ashwell Street may be limited by the 90 degree deviation in carriageway alignment and vegetation within the verge.

- The audit team would note however, that these are existing 'problems' that have not resulted in any PIC's and that the occurrence of large vehicles reversing along the access road are likely to be relatively infrequent, the potential conflict area relatively short (due to the location of the proposed pedestrian access at the eastern extent of Ashwell Street) and vehicle speeds low. On this basis, although the risk of a pedestrian/vehicle collision occurring are considered to be low, the likely increase in forecast pedestrian movements at the location resulting form the proposed development could increase the potential risks associated with these problems due to the carriageway alignment (i.e. 90 degree angle) and limitations this places on the inter-visibility splays between pedestrians entering Ashwell Street form the PRoW.

- 2.9 It is recommended that a formal NMU audit is undertaken for the proposed development and that the findings of the NMU audit be incorporated into the offsite highways improvements and provided for review by the Road Safety Audit Team at the Stage 2 RSA.
- 2.10 It is also recommended that 'pedestrians in carriageway' warning signs are provided at the Ashwell Street junction.

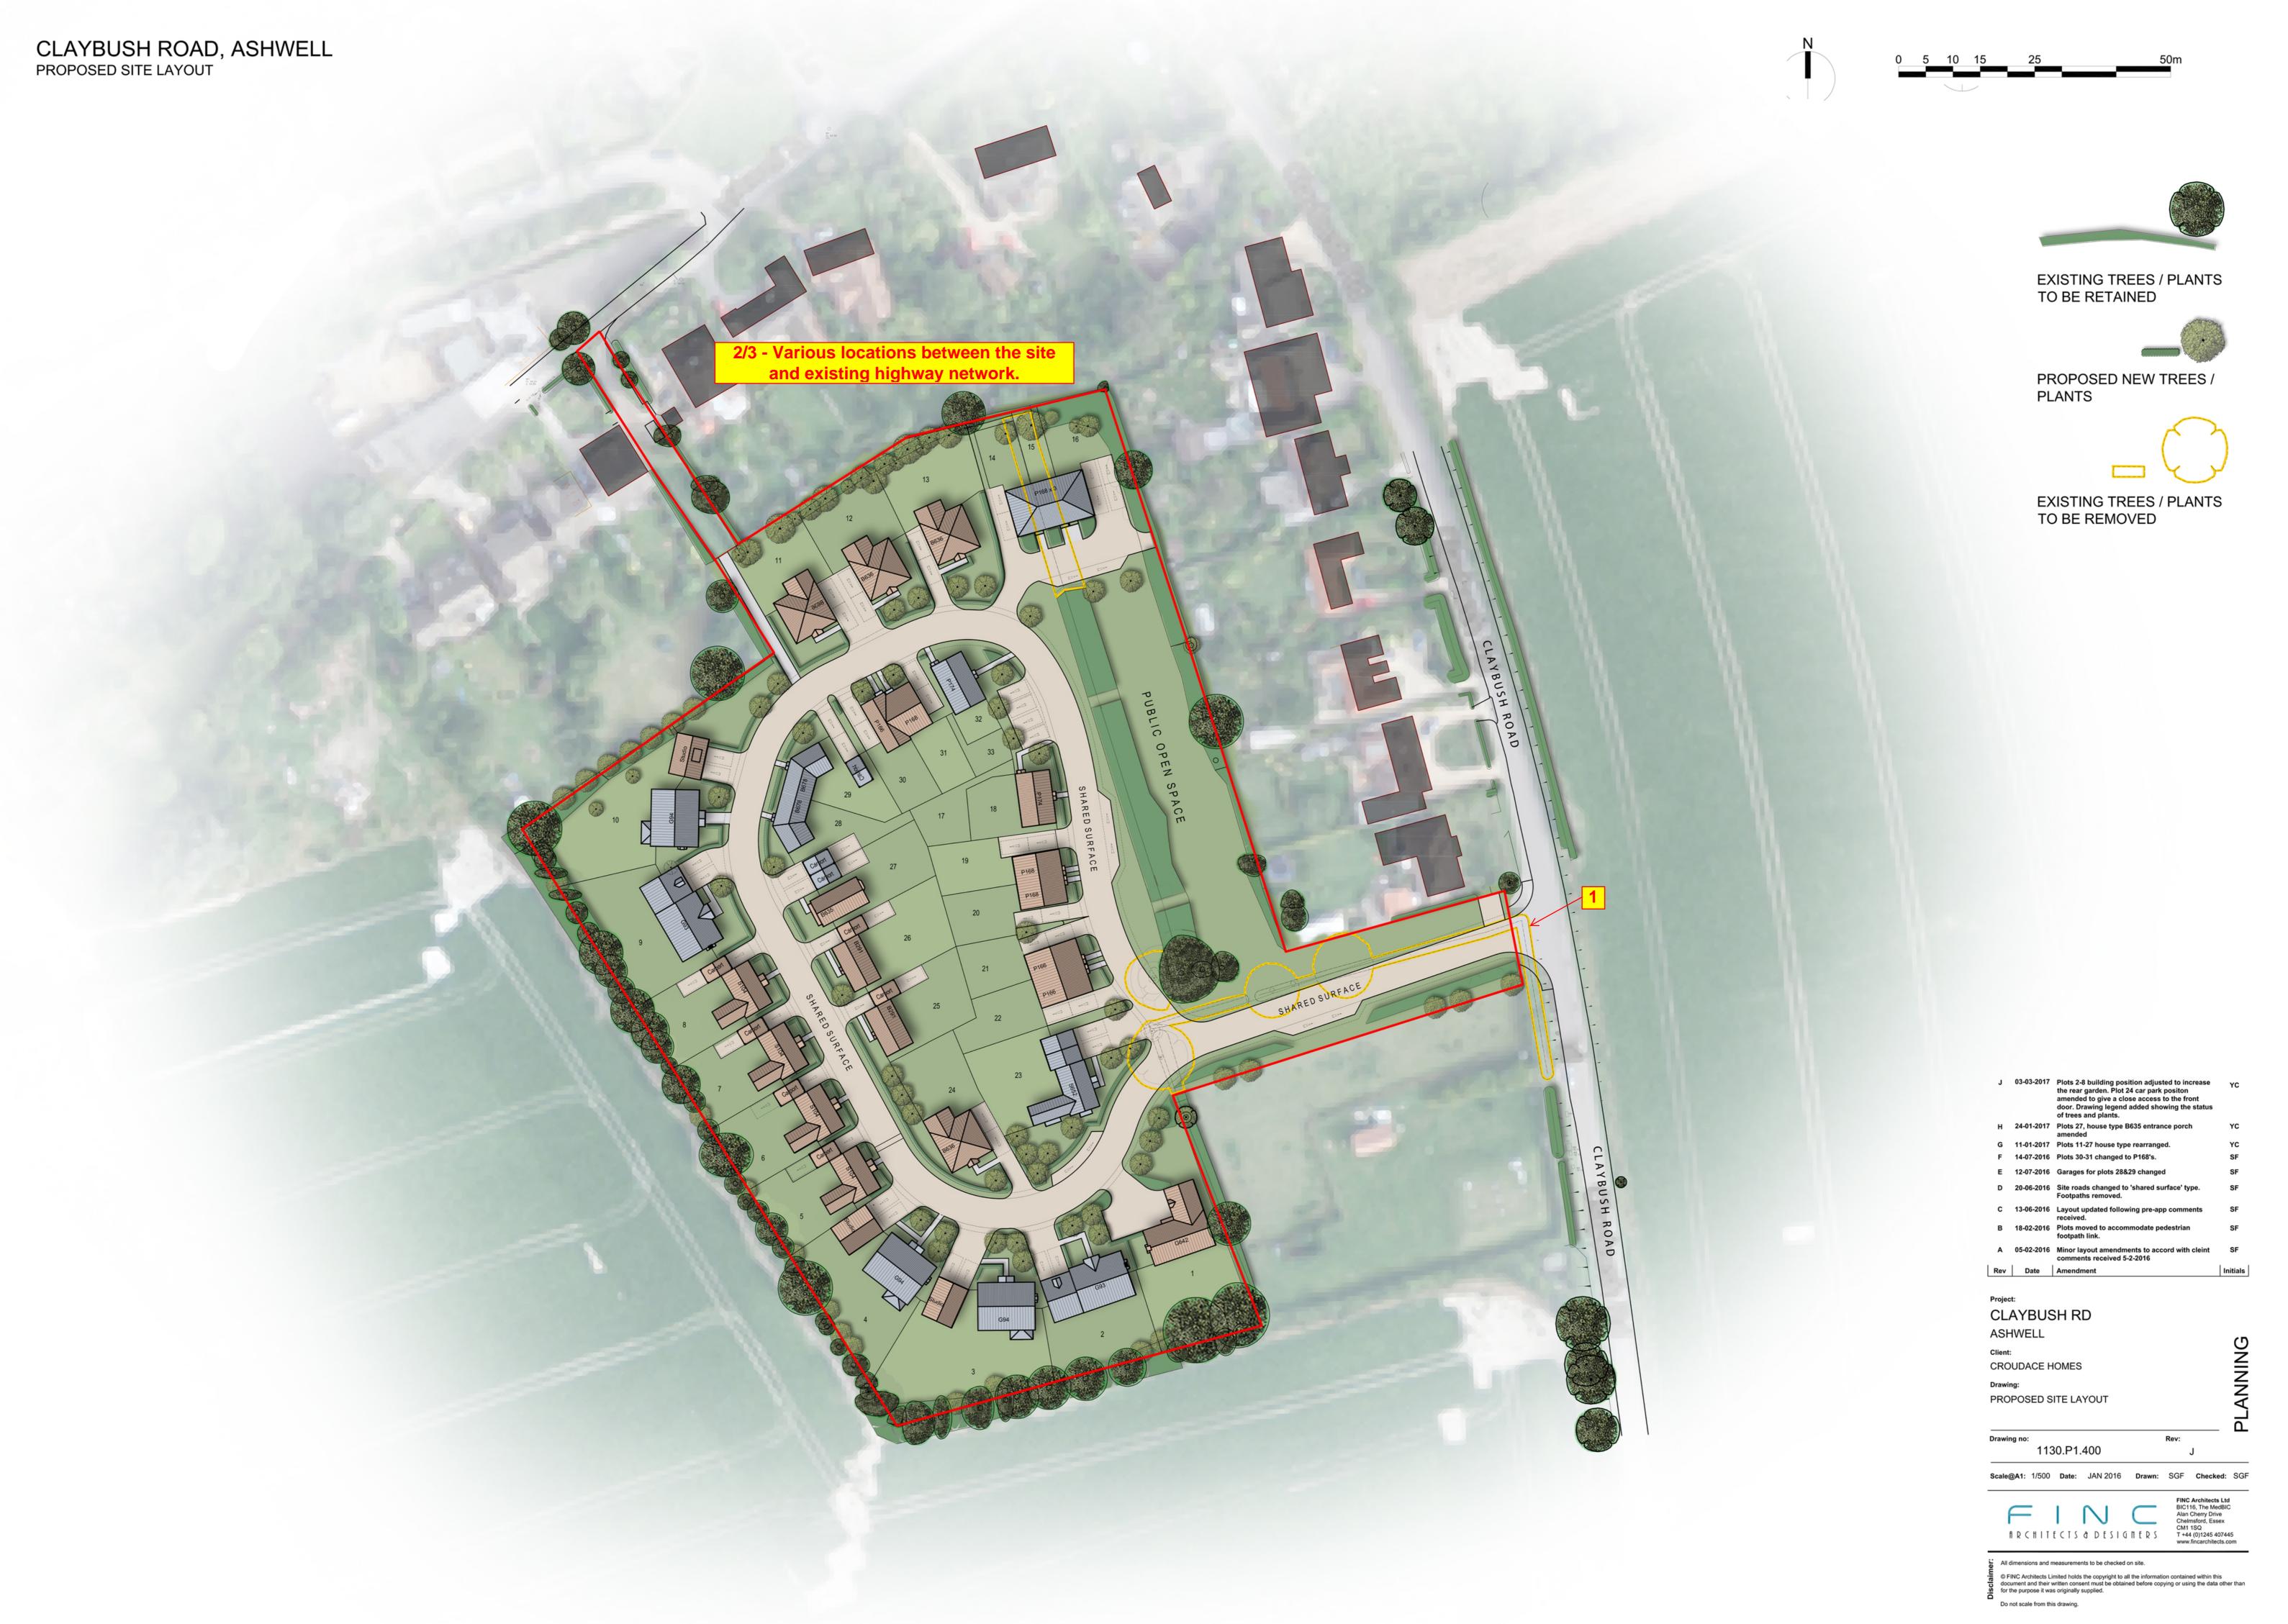
Location of Identified Problems

SUMMARY: Restricted visibility at the proposed site access could potentially result in injudicious turning manoeuvres form the site access which may result in shunt-type type collisions.

SUMMARY: Lack of continuity for pedestrians may result in an increased risk of slip/trip hazards for pedestrians or vehicle/pedestrian collisions.

SUMMARY: Increase in pedestrian movements along the section of Ashwell Street between the proposed site access for pedestrians and Ashwell Street 'junction' may result in an increase risk of pedestrian/vehicular collisions.

2.2 It is recommended that land ownership details be provided for review at the Stage 2 RSA to ensure that the proposed visibility splays can be achieved.

2.5 It is recommended that an assessment of the pedestrian connectivity to the site and local trip attractors is undertaken e.g. through a formal Non Motorised User (NMU) audit and that sufficient off-site pedestrian provision is provided for pedestrians to undertake their journey e.g. to the local school without the potential requirement to do so within the carriageway.
